Ancient building requirements and the evaluation of different lime-cement mortars compositions

Abstract: Although traditional mortars have demonstrated to have great qualities for preserving historic walls through centuries, they have been substituted by modern cement based mortars since the second half of last century. Even if in the last years the knowledge on lime mortars and the benefits of their use have been often pointed out, there are still a lot of difficulties at least in Spain, that make difficult their use in restoration work. The aim of this communication is to contribute to a better understanding of ancient walls principles so that the compatibility of lime mortars and the problems of cement based mortars can be evaluated in their conservation and maintenance and avoid future damage.

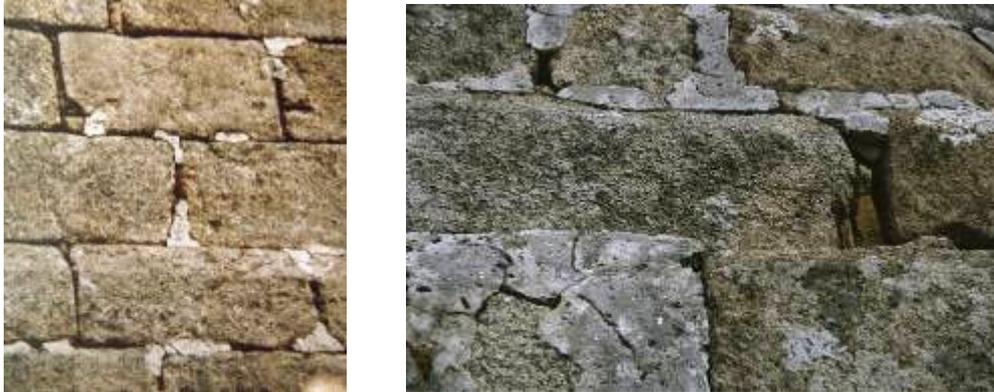
Figure 1. Deterioration process at S. Xiao Moraima due to the use of cement-based mortars

In terms of mechanical strength, ancient walls are based in the use of weak and low elasticity modulus mortars, so that their strength is not only lower than the stone of the wall but very low in order to be able to absorb differential stress and become a system of small dilatation joints. This system is only possible if we use really weak mortars, with enough low compressive strength and elasticity modulus E . But it is nowadays difficult to understand by persons involved with ancient walls restorations, as we have a strong influence of concrete technology where the problems comes from too less strength or too little cement in their composition. This influence makes people think often that if cement mortars are used or that if some cement is added to lime mortars, the behaviour of the wall will improve and wall maintenance may be avoided. But by contrary when cement is used in joints, specially in walls oriented to south where thermal expansion is stronger, systematically fall down, loosing their adherence to the ashlars and breaking the ashlar's edge as it can be seen at St. Xiao de Moraima (Figure 1). This deterioration process is faster when the cement content is higher.

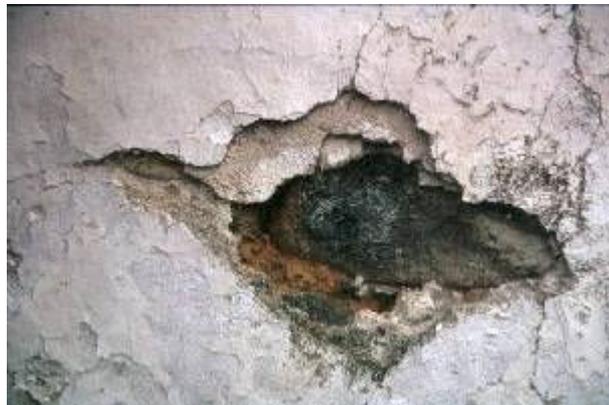
Figure 2. Loose of adhesion of renders at Sta. M^a de Penamaior due to cement-based mortars.

Also when not enough low strength and not enough low elasticity modulus E mortars are used in the renders of masonry made of rubblework, they systematically fall down, as rubblework has a much higher strain capacity than ashlar work and need a much higher modulus of elasticity in its renders. Cement and cement-lime mortars with different cement contents have been found to develop loose of adhesion and sometimes partially broken and fall down, as we can see in the case of Sta. M^a de Penamaior (Figure 2), although some other reasons may contribute to this behaviour which be analysed straight [5, 6].

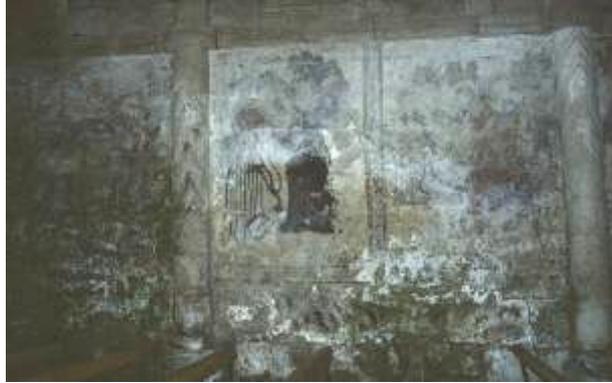
Figure 4. Interior condition of St. Xiao de Moraine due to the used of cement mortars in the outside: biological deterioration of mural paintings and soluble salt deposits.

The problem of low water-vapour permeability is that they will not contribute to the evaporation of the water content that may have been introduced in the interior of the wall due, for example, to water table change, but will increase the water content in the interior of the wall. The problem of it is all the different deterioration process that water can develop: a) it can get inside the porous structure of the stone originating mechanical stress due to expansiveness of ice, or to chemical reactions that not only may generate internal stress but also a chemical deterioration process of the stone, b) it can generate a evaporation process through the interior facade of the wall, when permeable mortar cover them, like the mural paintings we find in most of Middle Ages churches, causing then damage on the surface, due not only to salt deposit stress but also to a biological deterioration process helped by environment conditions: temperature around 20°C and 80%RH, and algae, Diatoms and Cyanobacteria growing. This is what happened at the interior fasade of St. Xiao de Moraime (Figure 4), due to the use of cement mortars in the exterior joints of the wall and the evaporation of water through the interior facade (Figure 5), where different biological colonies were found: Cyanobacteria alone or mixed with Diatoms in big colonies, forming thick and soft blue-green and white sheets, and other algae, forming very thin and gelatinous green layer, which cause serious disintegration on the mural paintings [4, 5, 6].
